PETER HART

A dog of a trailer

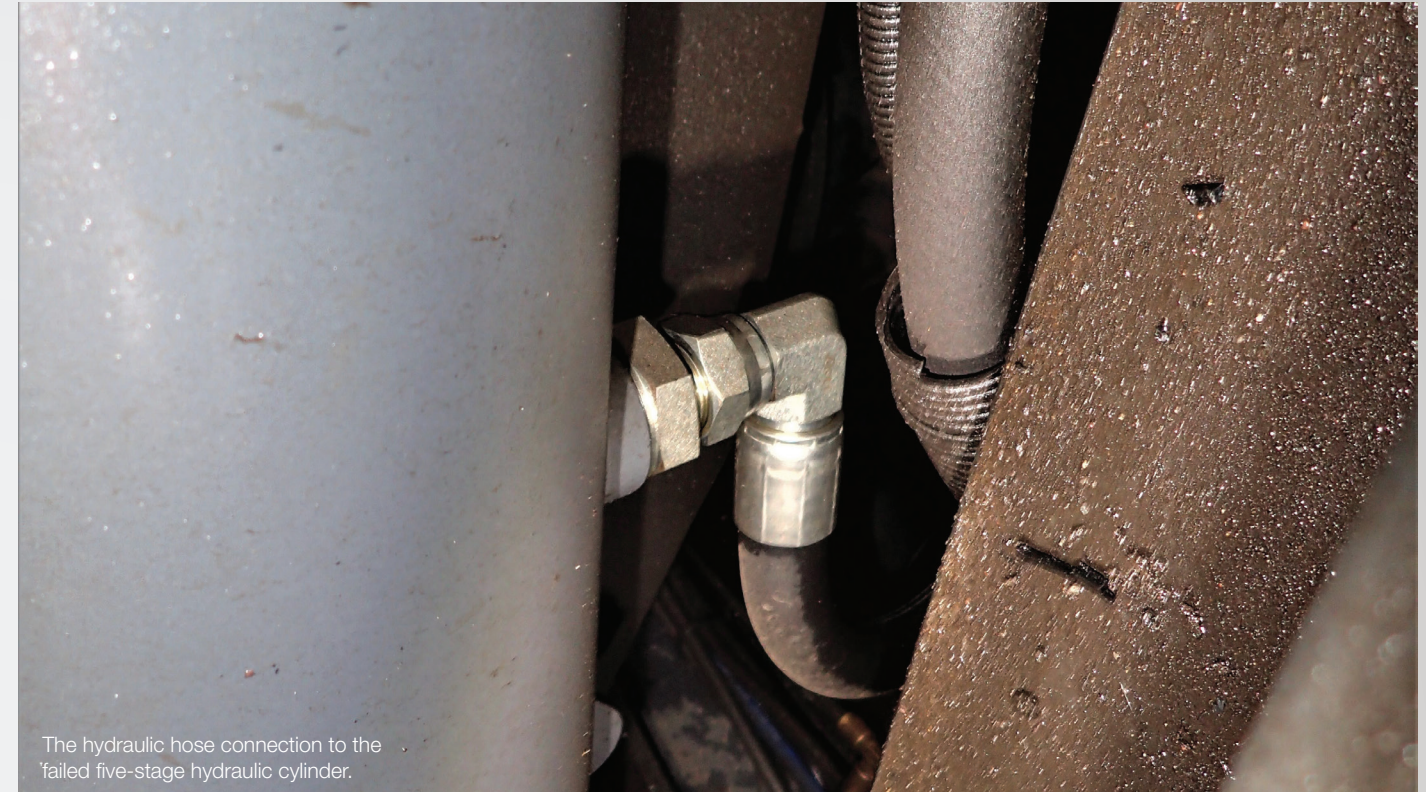
The hydraulic hose connection to the failed five-stage hydraulic cylinder.

Hydraulic oil pressure is generated by a pump that is driven by the engine PTO. Hydraulic control systems can be open-centre or closed-centre. Open-centre systems have continuous flow and intermittent pressure. With the pump turning, oil is pumped through a central open path in the control valve and back to the reservoir. If the directional control valve is operated, flow is diverted into the cylinder load. Closed-centre systems have intermittent flow and continuous pressure. If the directional control is operated, a pathway to the cylinder is revealed and simultaneously pressure signal information is delivered to the pump from the directional valve, signalling the pump to produce flow. Both types of hydraulic systems can be used on tip-trucks and tip-trailers. Most Australian hydraulic systems for tip-trucks and tip-trailers are open-centre system so oil flow is bypassed to the tank unless the cylinders are being filled. The root cause of the cylinder failure seen in Figure 1 is that the tip-truck put out excessive hydraulic pressure to the

trailer. Because of the additional load, the cylinder on the four-axle dog trailer has a larger diameter than on the old three-axle dog trailer. The proof pressure of all the cylinders is 190 Bar. The burst pressure based on material limits is higher for the smaller diameter cylinder than the larger diameter cylinder, because it has a smaller diameter, but with the same wall thickness. The smaller cylinder could take the pressure of 220 + Bar the tip-truck can put out, but the larger cylinder could not! A serious failure resulted and the trailer bin fell down. It could plausibly have killed someone, but didn't, this time. Hydraulic pressure compatibility is not guaranteed by technical standards because the standards (based on AS1418) do not consider the interconnection of different systems. Valves have emerged such as the OP-22 tipper open-centre valve that provide a useful flow rate and pressure limit for tip-truck and tip-trailer compatibility. But there are other valves in use that put out excessive pressures, possibly only for short periods. Standards do not specify maximum hydraulic pressure. This is obviously a problem. There were three factors that contributed to the failure of the lifting cylinder on this new four-axle top-trailer. Firstly, the

hydraulic pressure from the tip-truck was high. Second, the burst pressure on the trailer lift cylinder was relatively low. I estimate it was 260 Bar, which is a Factor of Safety based on the proof pressure of $260/190 = 1.37$, which is low. Thirdly, the trailer was manufactured without any burst and over-pressure valve on the tip-trailer cylinder. Such protection is a basic safety requirement. It again indicates that tip-trailers are being built and plated with Federal approvals, that do not comply with basic safety principles that should come out of a hazard and risk assessment.

Hose burst protection is a fundamental requirement for lifting cylinders. If the flexible hose that supplies the cylinder should fail, the hydraulic oil will be released forcefully and the cylinder will come down hard and fast. To protect against such a failure, a burst valve must be used. There are two types. One type is a restrictor, which is described as a 'velocity fuse'. It slows the oil release down. The second type is a tipper safety valve, which shuts off flow when the pressure across the valve is above limit. Safety valves can also be obtained that provide cylinder pressure protection. However, they can only be used on the tip-truck because they need a reservoir to received oil bypass. I have written previously about the complete disconnect that exists between the Federal vehicle standards rules (ADRs) and the state and territory plant-equipment safety rules. Here is another example where the rules are not adequate to protect the community. So how can the safety of tip-trailer safety be improved? My proposals are in the text box.

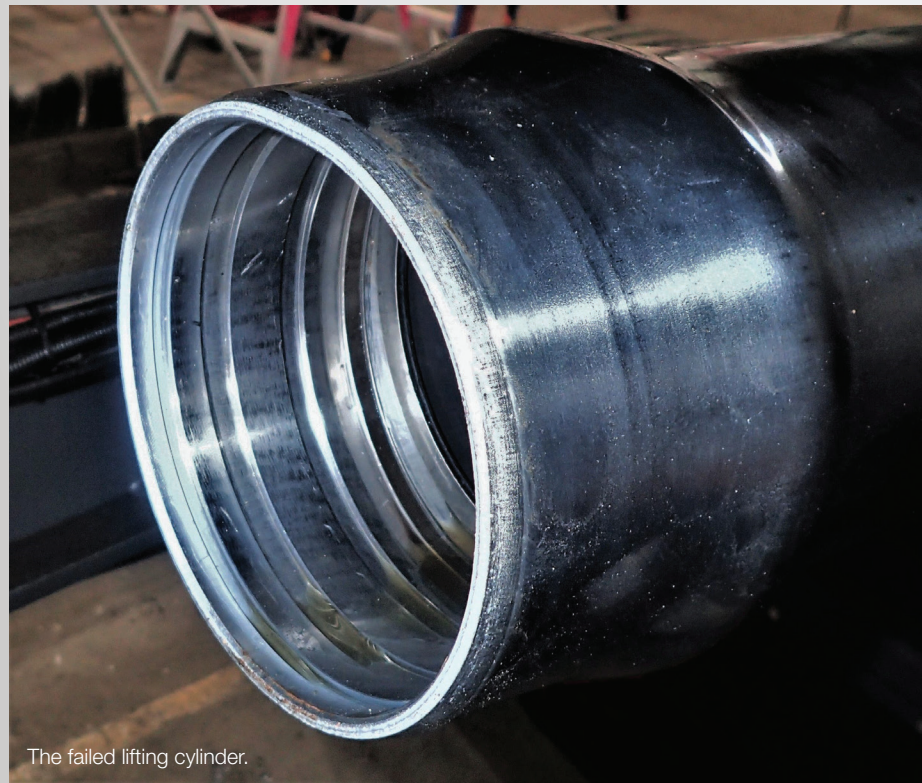
The failed lifting cylinder.

This is the third article I have written this year about dog trailer safety (May '22 and June '22). I recently investigated a serious failure of a hydraulic lifting cylinder on a 4-axle tip-trailer. The new cylinder came apart at the second stage when the trailer was discharging about 20 tonnes of rocky fill. The metal cylinder swelled at a thin section corresponding with a pressure ring. The swelling indicated that the hydraulic pressure greatly exceeded the rated pressure of the cylinder. But why? Fortunately no
